Failure of Solar Inverter Transformers and Power Transformers in Solar Power System - Causes and Remedies

Causes for failure of transformers

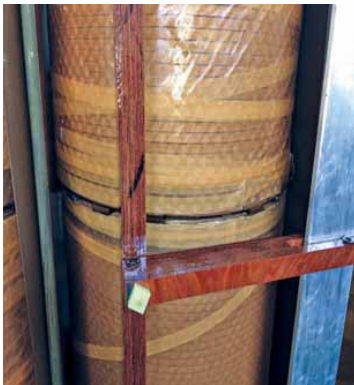
Since these transformers are getting loaded for about 6 – 9 hours in a day (may be 8 AM to 5 PM), there is a tendency to under estimate the operating conditions and choose design parameters in such a way that the design becomes more competitive to meet the competitive price demand. This results in over heating of windings, development of hot spots in windings and generation of gases resulting in tipping of transformers under OTI / WTI operation, BR etc. (Photo 1)

Photo 1 - Insufficient Cooling of Windings Resulting in Thermal Failure

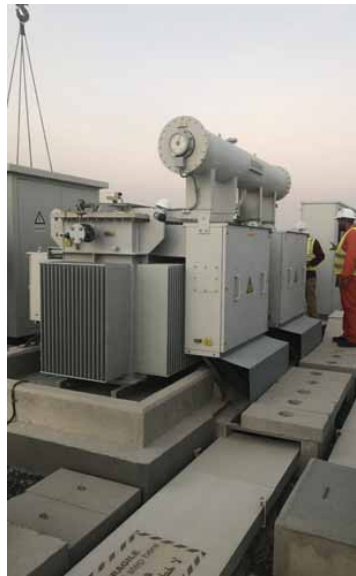
Also due to inadequate cooling area to dissipate the losses generated in the systems during the operating conditions even though the transformers have been successfully tested in factory for Temperature rise. (Photo 2)

Photo 2 - Insufficient Cooling of Total Losses Generated

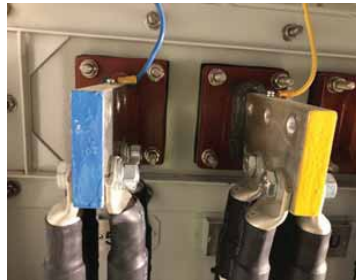
Cracking and leakages from LV epoxy bushings due to differential thermal coefficient of expansion of resin system and Copper material (Photo 3)

Photo 3 - Breaking And Leakage From LV Epoxy Bushings

7.8 Manufacturers to look at the possibility of using fiber glass LV bushings instead of Epoxy bushings to avoid leaks due to cracking of epoxy bushings as described above, Refer photo, 17

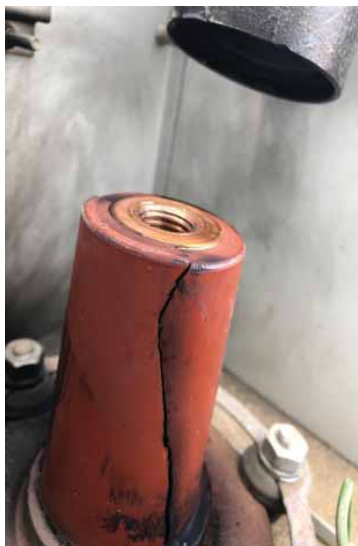
Improper selection of HV bushings resulting in failure due to inadequate creepage for the voltage class (Photo 4)

Photo 4 - Failure of HV Elastimould Bushing due to Inadequate Creepage Distance

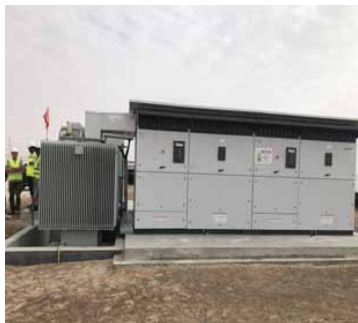
Thermal heating of transformers due to insufficient natural cooling (Photo 5 and 6)

Photo 5 - Impair of natural cooling due to blockage from inverters mounted close to the transformer

7.4 The users to take care of proper installation considering the cooling requirements based on the heat generated in the transformers due to no load loss and load losses

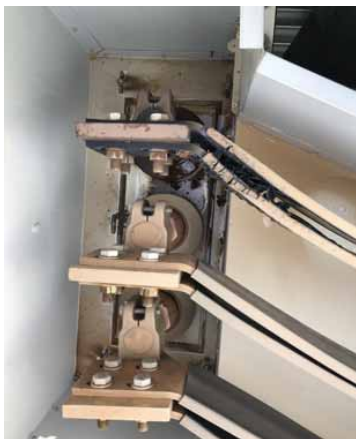
Photo 6 - Burning Of Lv Side Bus Bar Sleeve Due To Insufficient Cooling (Bus Duct Blocking The Heat Dissipation)

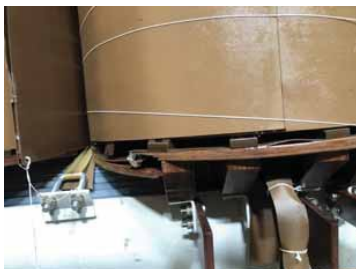
These kind of transformers are subjected to frequent short circuits in the systems (Earth faults). If the materials used are of inferior grade or sufficient mechanical supports are not provided due to improper understanding of operating conditions the Transformers are prone to fail under dynamic short circuit forces. (Photo 7, 8, 9, 10)

Photo 7 - Inadequate (Improper) Mechanical Support

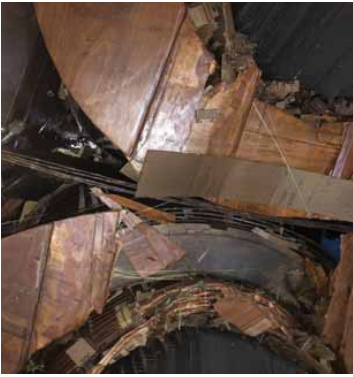
Photo 8 - Poor Quality of PW Rings

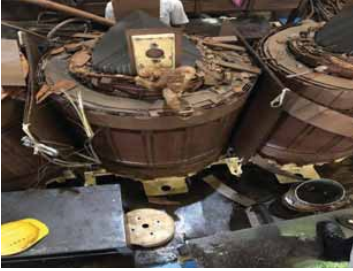
Photo 9 – Failure of LV Windings in all three Phases under Dynamic Inabiltiy to withstand Short Circuit Forces

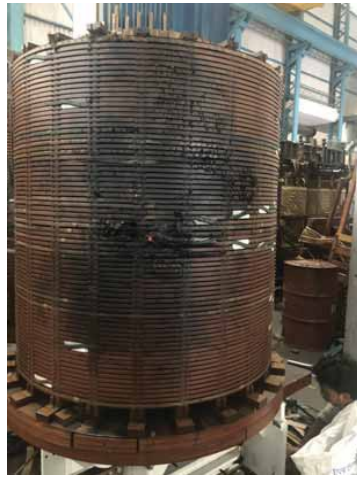
Even though the transformers have been successfully tested in the factory for all the dielectric tests as per relevant standards, it has been noticed that there are many cases of dielectric failures of these kind of transformers in the system. (Photo 11, 12, 13,14). The dielectric failures have resulted in thermal failure damaging the complete HV and LV windings.

Over voltages in the solar system can be due to lightening impulse, switching surges, resonant over voltages due to the transformer inductances resonating with cable capacitances. It is reported in many technical journals that these resonant voltages can be of very high magnitude causing severe dielectric failures. One such technical reference is listed under the references.

Photo 11 - Dielectric Failure Resulting in Short Circuit Failure In HV Windings

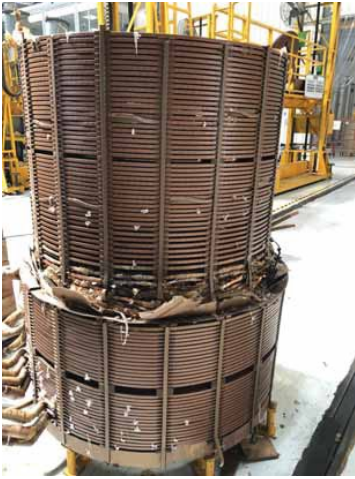
Photo 12 - Dielectric Failure Resulting in Short Circuit Failure of Windings

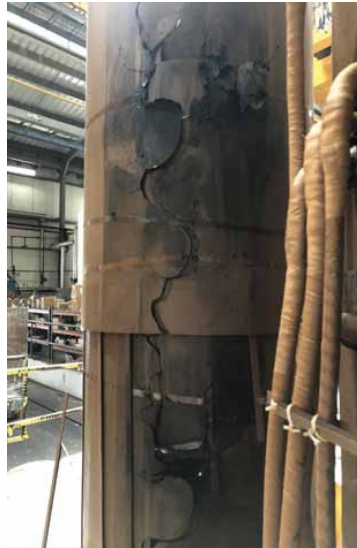
Photo 14 - Dielectric Failure of Insulation System due to over Voltages

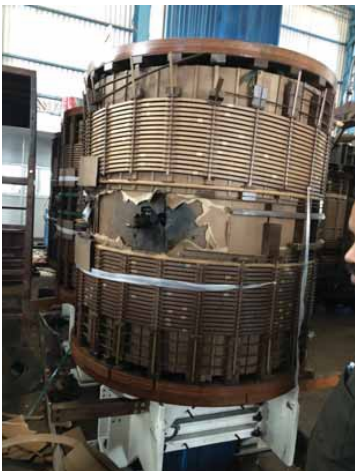
Photo 13 - Dielectric Failure of HV Windings due to over Voltages
