REPAIR FOR PERFORMANCE IMPROVEMENT OF DISTRIBUTION TRANSFORMER ASSETS

**Report on Repair for Performance Improvement of Distribution Transformer
for MPPKVVCL**

For MPPKVVCL, Indore

October 2019

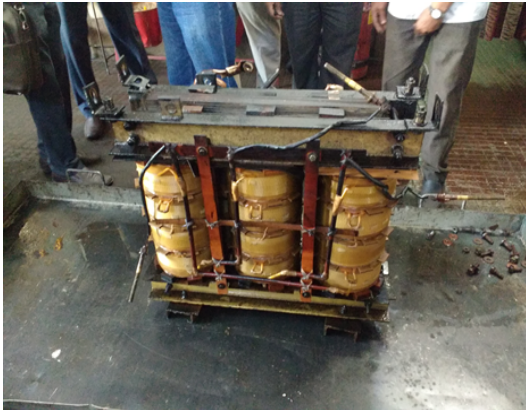
Figure 1. Acquired failed DT

The execution process was undertaken with pre-repair testing of failed DT at MTRU. No load loss value and full load loss value were measured. The testing was undertaken in presence of MPPKVVCL representative as per IS 2026. Some images are shown below:

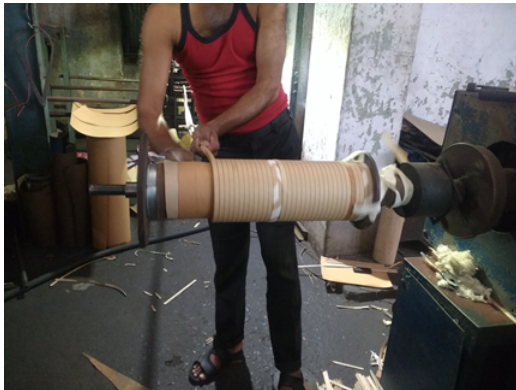
Figure 5. LV winding

- Unstacking of core laminations and restacking them tightly to reduce air gap between laminations
- Procuring right kind of material (electrolytic grade copper in this case) for winding
- Placing LV and HV winding as per design spec and assembling
- Assembled transformer was moved for oven drying to remove moisture
- Eventually, oven dried transformer was placed in tank as final assembly
- Completing painting process following norms

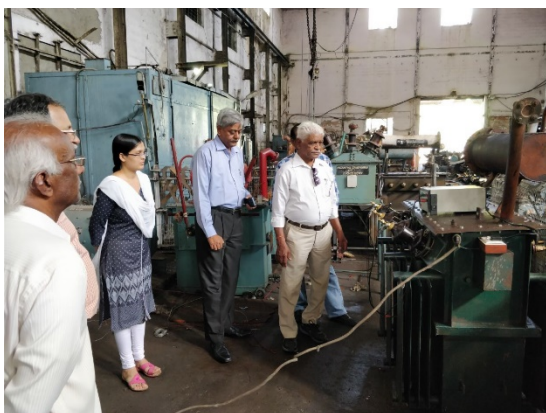
Figure 9. Setting up connections for testing

After repair, post repair testing was undertaken in presence of MPPKVVCL representative as per IS 2026. Some images are shown below:

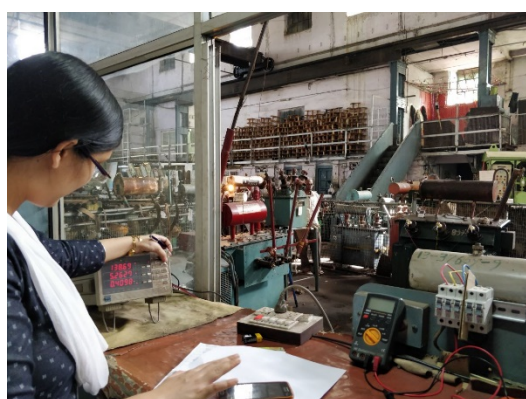
Figure 11. Post Repair Test Measurements

After conducting all tests, results were obtained for various parameters in reference to the baseline measurements. Following are the results obtained:

Key Design Parameters	Unit	Specification	Baseline (As-Is)	Actual Post repair results (measured at MTRU)	Actual Post repair results (measured at ERDA)
Capacity	kVA	100.00	86.41*	100	109**
Year of Manufacturing		-	2013	-	-
Flux Density	Tesla	1.55	-	-	-
LV Winding Material		-	DPC Al	DPC Cu	DPC Cu
# of LV Turns	#	-	76	76	76
HV Winding Material		-	DPC Al	DPC Cu	DPC Cu
# of HV Turns	#	-	3344	3344	3344
Total Loss	Watt	2020	2616	1461	1463
Impedance	%	4.5	3.84	4.12	4.21
Total Winding Weight	kg	-	46.62	192.36	192.36

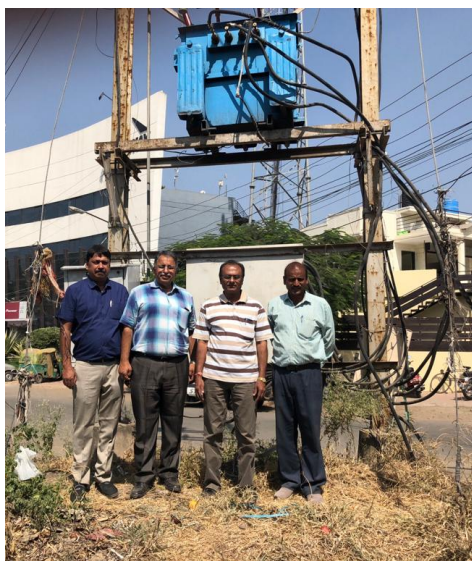
Figure 17. Metering on Repaired 200 kVA DT

Post Repair metering was done on both sides of the DTs (both 100 kVA and 200 kVA) with MPPKVVCL team. The metering will help monitor the performance of Repaired DTs.
