Failure of Solar Inverter Transformers and Power Transformers in Solar Power System - Causes and Remedies

Causes for failure of transformers

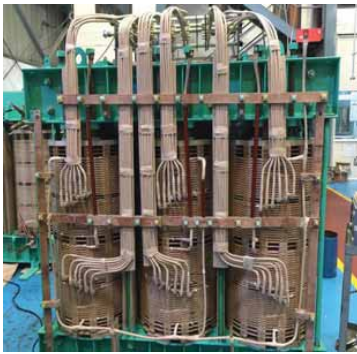
Photo 15 – Good Practice Of Lead Routing And Coils Anchoring

- 7.1 Adopt robust design considering the system operating conditions like frequent earth faults, resonant over voltages, fluctuating load conditions, frequent switching on and off, over voltages due to vacuum switching on/off, not just design for competitive price. Provide sufficient cooling considering the overload in the systems and the harmonics from the inverter side. Calculate the winding hot spot temperature more accurately. Adopt latest analyses tools like FEM method, MATLAB etc. to analyze short circuit forces, voltage distribution and mechanical structure design.
- 7.2 Use best grade of insulation materials to meet the system operating conditions.
- 7.3 Adopt good manufacturing practices like proper lead routing, anchoring of coils for containing both axial and radial forces. Refer photographs 15 and 16

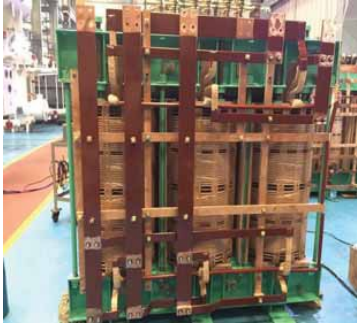
Photo 16 – Good Practice of LV Bus Bars Anchoring.
